Razer Blackwidow Tournament Edition Keyboard Metal Bar on Keys Replacement

This guide is designed to help Razer Users replace the metal bar located on keys.

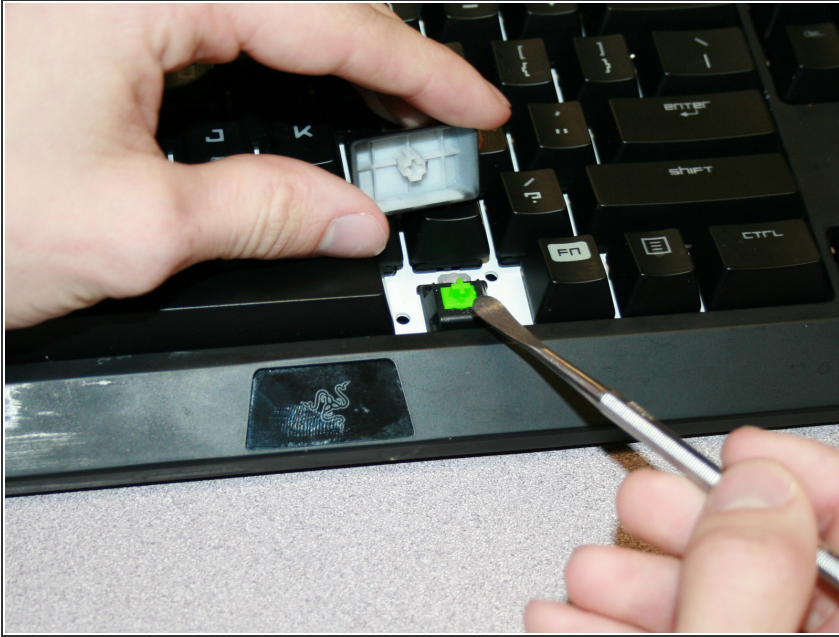
Step 1 — Metal Bar on Keys

- ⓘ Before you do anything, take a picture of the entire keyboard so as to know where the keys go at the end.
- Gently start to remove the keys surrounding the keys with the bars in them.

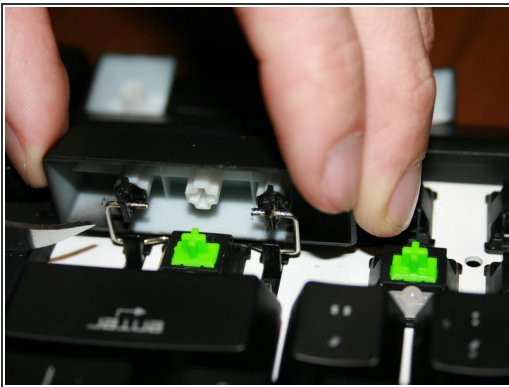
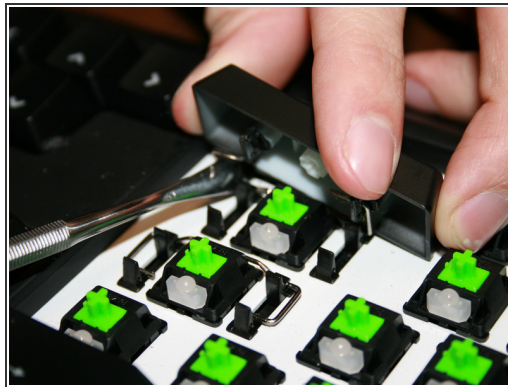
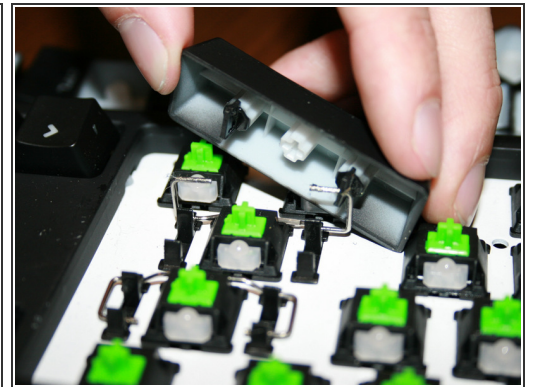
Step 2

- Move the key itself off of one side of the bar from where it connects to easily allow the other side to be removed as well.
- Another way to do it is to push the bar itself out gently with the metal spudger.

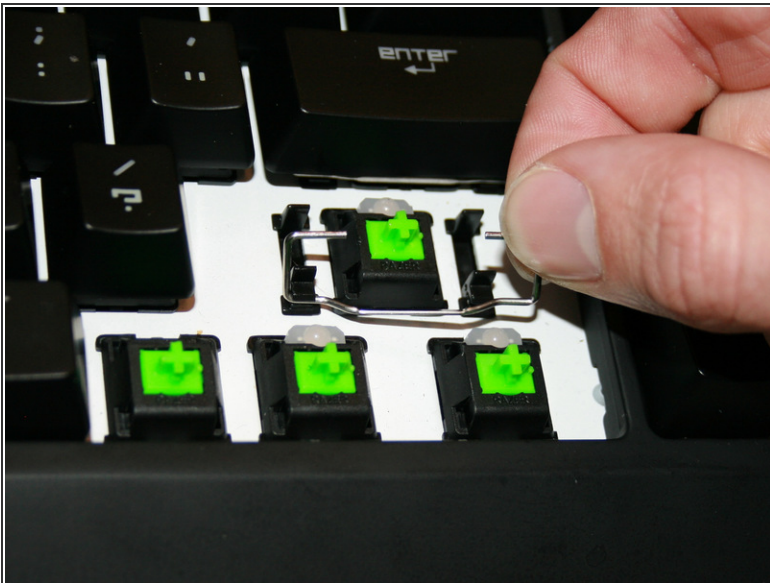
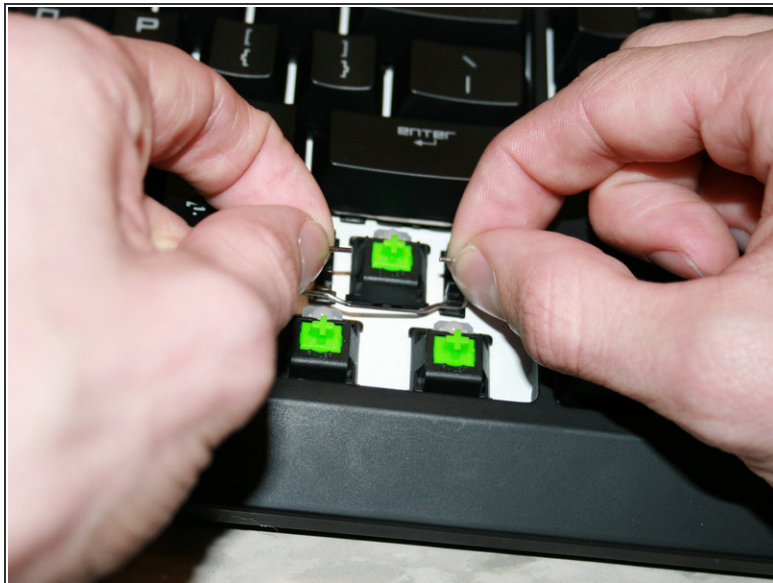
Step 3

- Gently pop the bar out from its sockets.
- Pop the new bar back into the sockets.

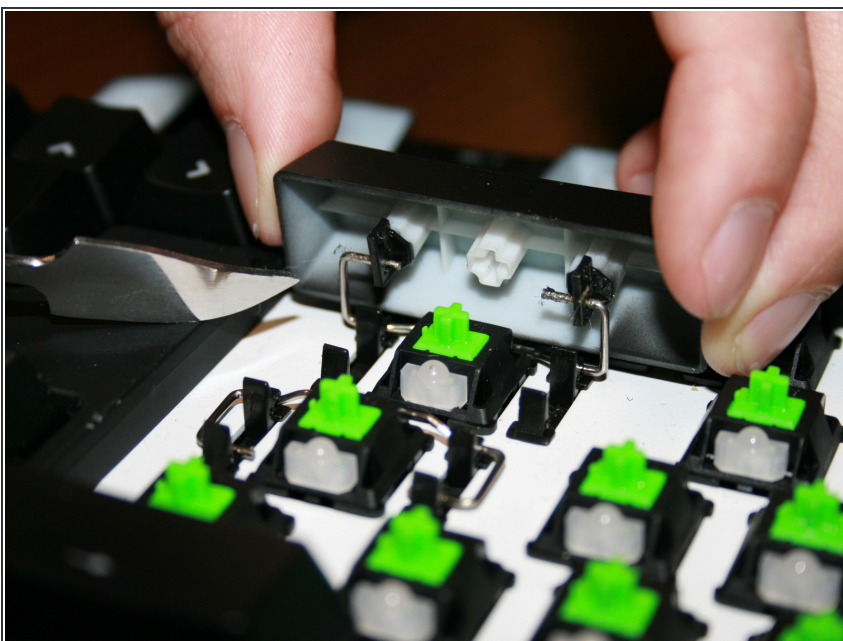
Step 4

- Gently slide one side of the key into the bar and then use the metal spudger to pop the other side into place.
- ★ Use the picture from the beginning if necessary to make sure all the keys are in the right place.
